Report: [REDACTED] -Inspection Address: [REDACTED]

Confidential Inspection Report

NATIONAL HOME INSPECTION SERVICE INC.

SUMMARY OF AREAS REQUIRING FURTHER EVALUATION

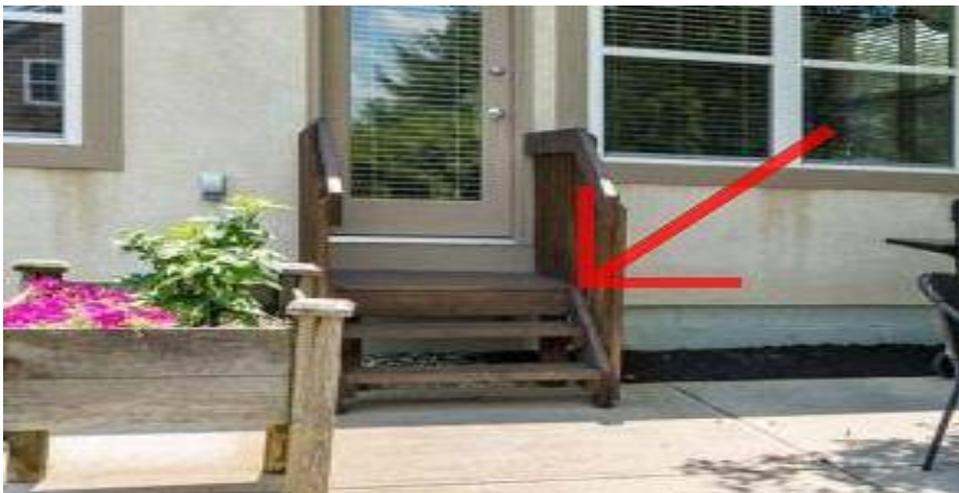
The rear wood stairs had a moisture damage board where the stairs attach the home (under the door) and will need professionally repaired as required. Recommend contacting a qualified specialist for further evaluation and recommendation and actual cost of repair or replacement.

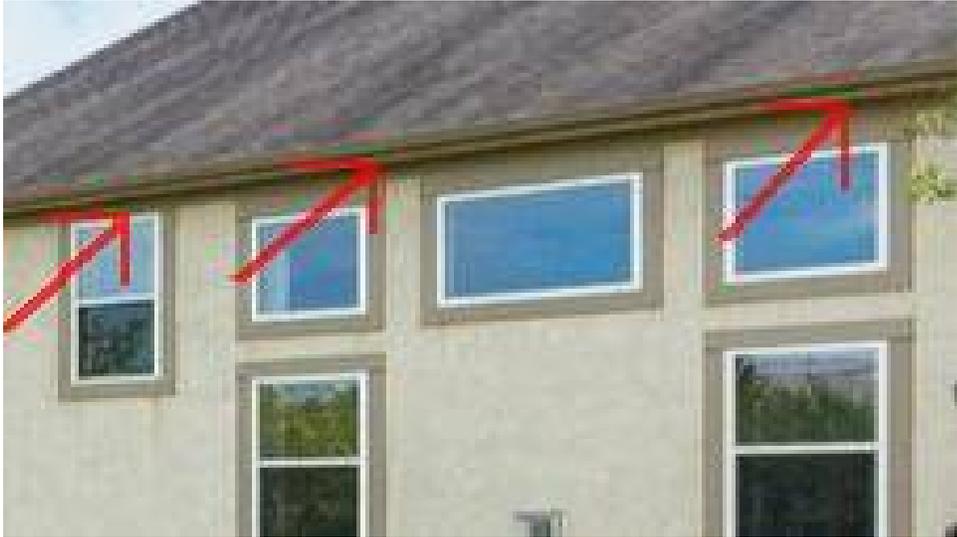
The composite trim under the gutter on the rear of the home had moisture damage that will need professionally repaired. Recommend contacting a qualified exterior trim specialist for further evaluation and recommendations and actual cost of repair or replacement.

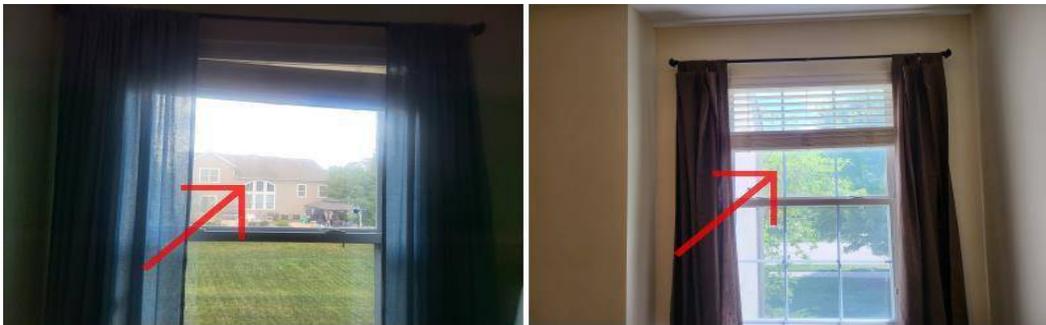
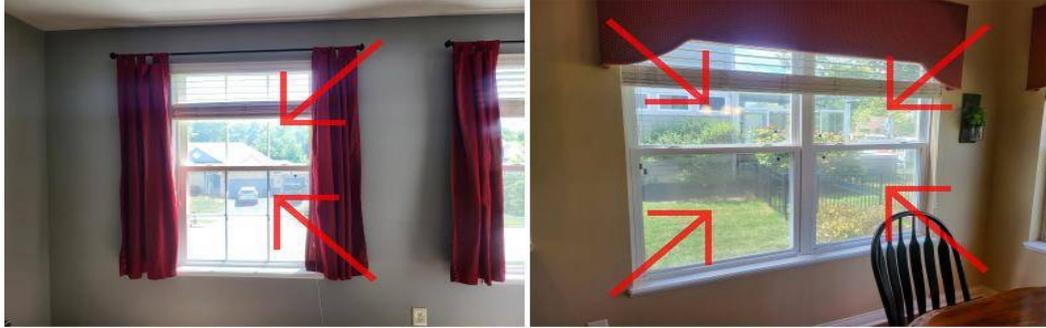
The dinette side, master bedroom left, right guest bedroom and left windows have visible broken seals (moisture between panes of glass) and will need further evaluation. Recommend contacting a qualified glass specialist to determine the exact "number of windows" that will need repair or replacement.

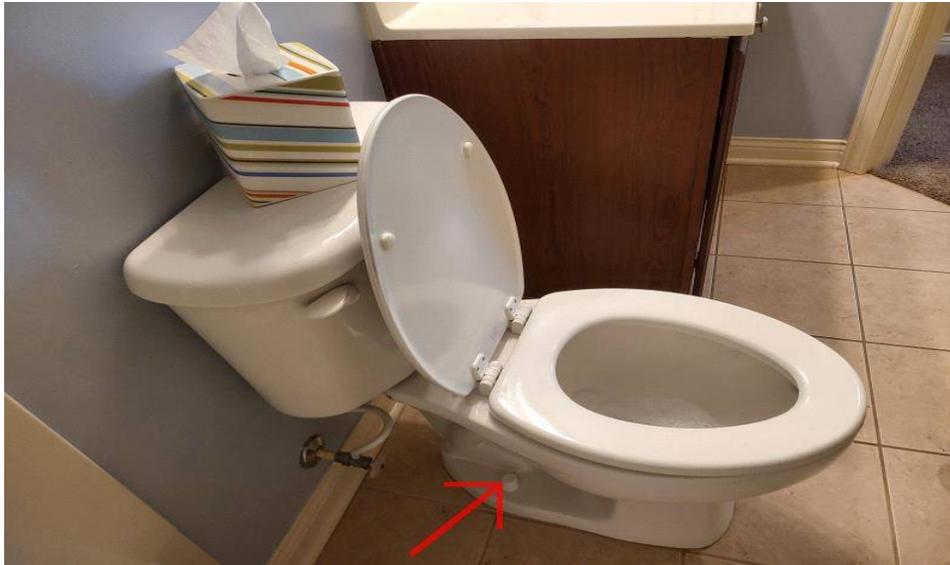
The upstairs hall bathroom commode is, The visible area(s) of the bathrooms were inspected and appeared functioning as intended except

for comments-made and normal wear and tear. See Plumbing Fixtures for additional information. *extremely loose and will need professionally secured as required to prevent future damage.*

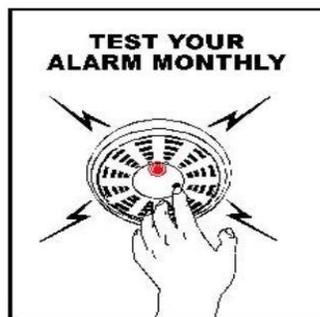
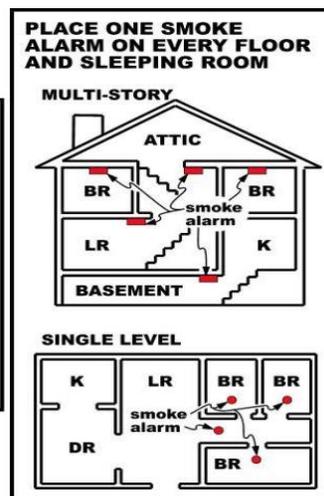
Recommend installing or updating old outdated Smoke and/or Carbon Monoxide Detectors in home for life-safety.

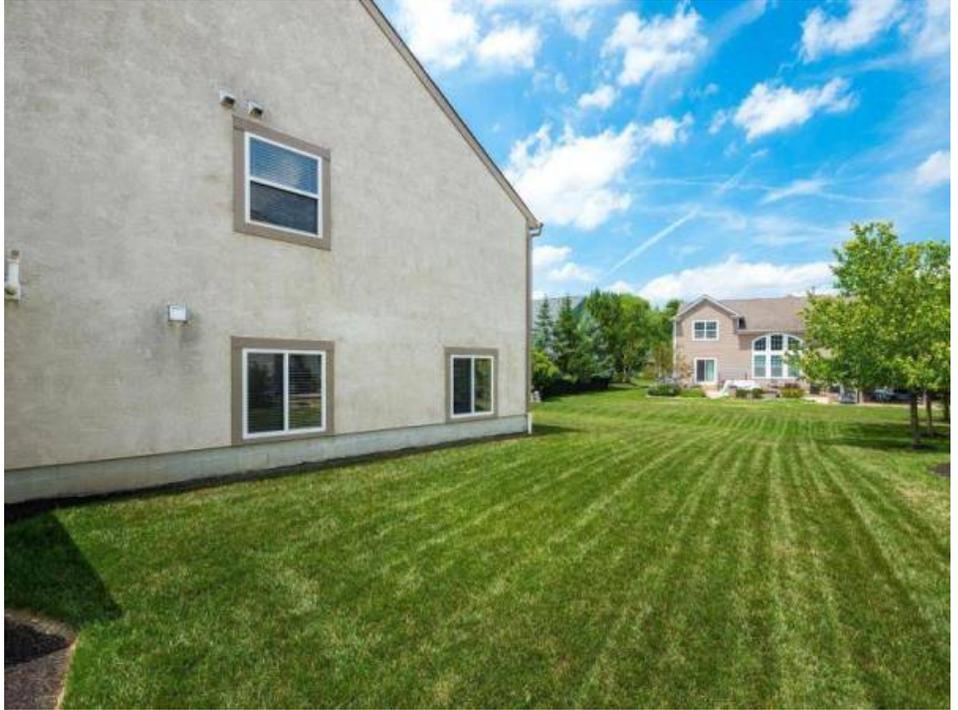
Recommend maintaining the grade around the homes exterior foundation by maintaining a minimum slope of at least one inch per foot drop extending out at least five feet from the foundation to prevent unwanted moisture related problems, such as; wood rot, mold, mildew, fungi, unwanted insect activity, wet basements and crawl spaces, unwanted hydrostatic ground pressure that could cause structural damage to the homes foundation walls.

NOTE: Maintaining the grade around the homes foundation is probably the single most important thing you can do to help prevent future moisture related problems.

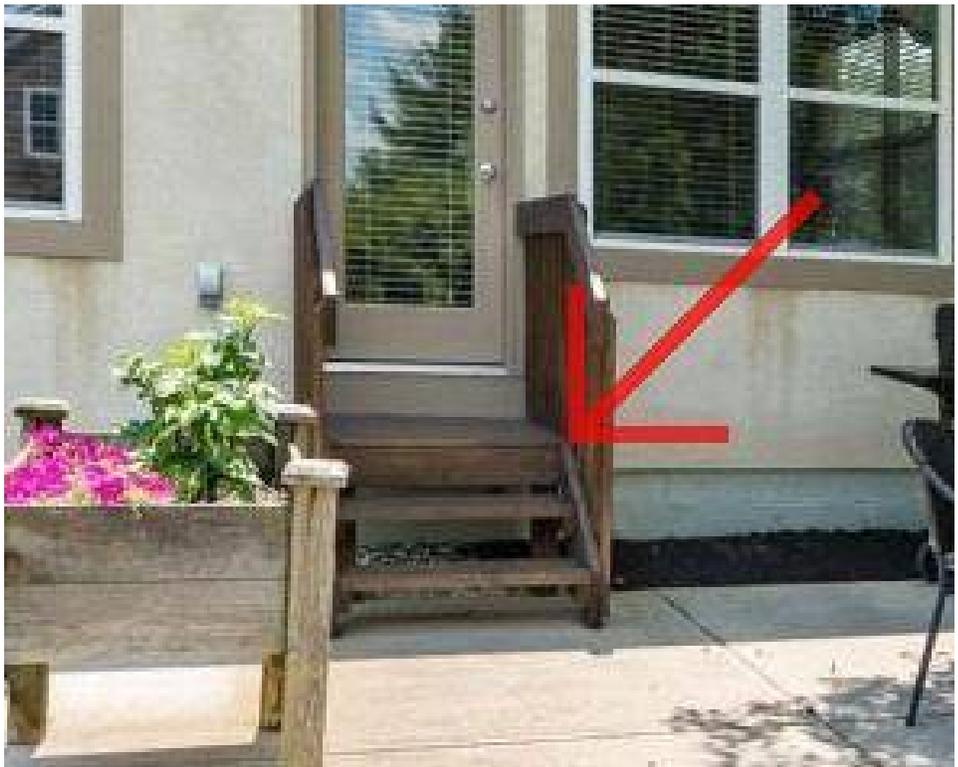
The rear wood stairs had a moisture damage board where the stairs attach the home (under the door) and will need professionally repaired as required. Recommend contacting a qualified specialist for

further evaluation and recommendation and actual cost of repair or replacement.

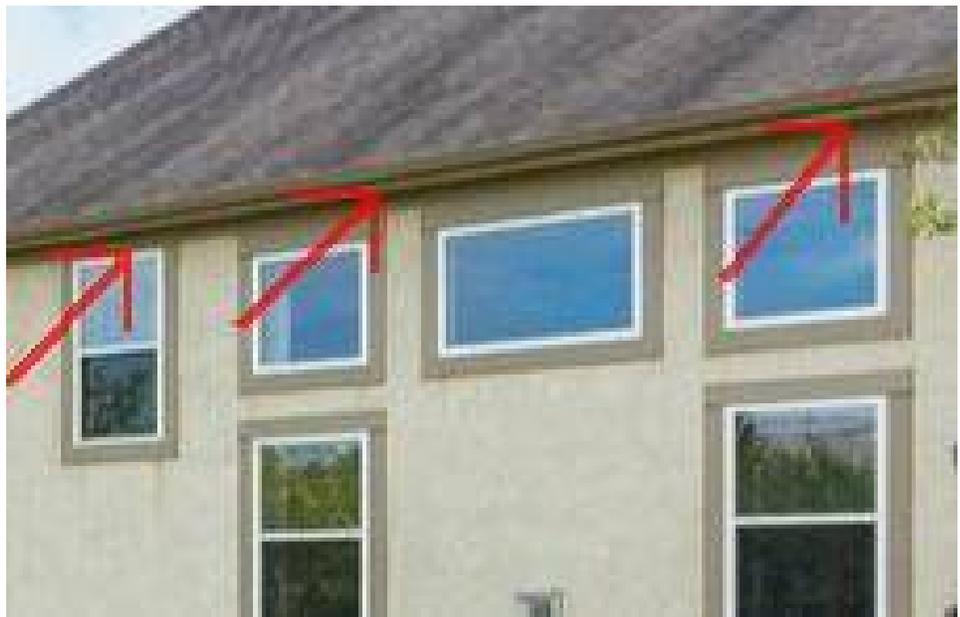
The composite trim under the gutter on the rear of the home had moisture damage that will need professionally repaired. Recommend contacting a qualified exterior trim specialist for further

evaluation and recommendations and actual cost of repair or replacement.

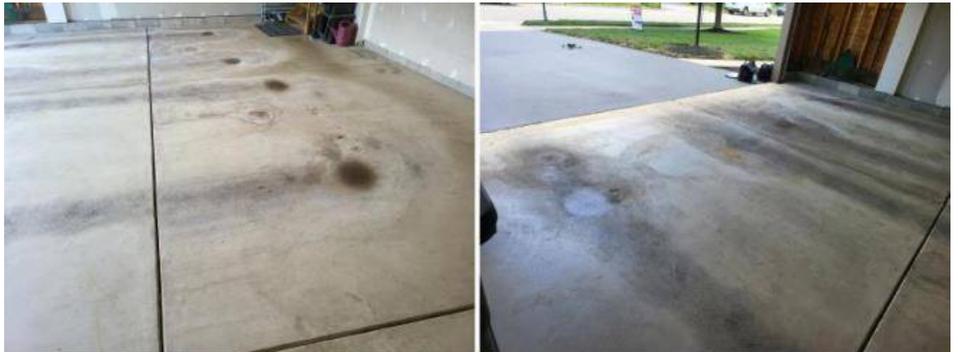
Concrete Slab. The garages concrete floor has typical stress cracks. Lawn Equipment. Extensive Storage. Tools and Equipment. The garage floor was not all visible and could not be fully inspected. *The garages concrete floor has surface spalling or scaling due to winter road salt.*

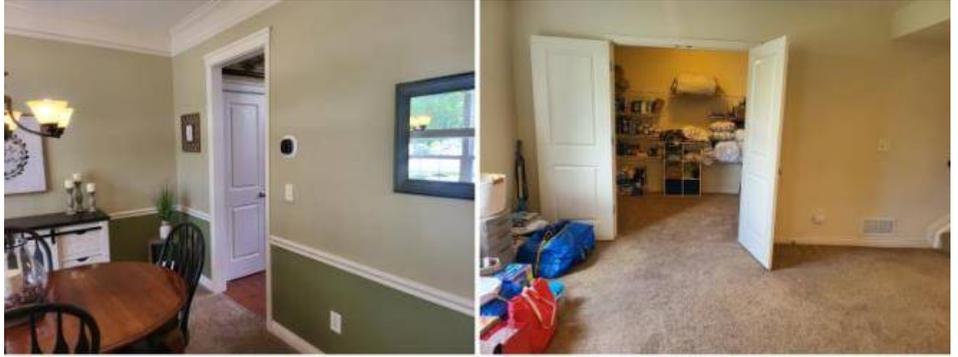
The homes drywalled walls have typical stress cracks from settlement or movement.

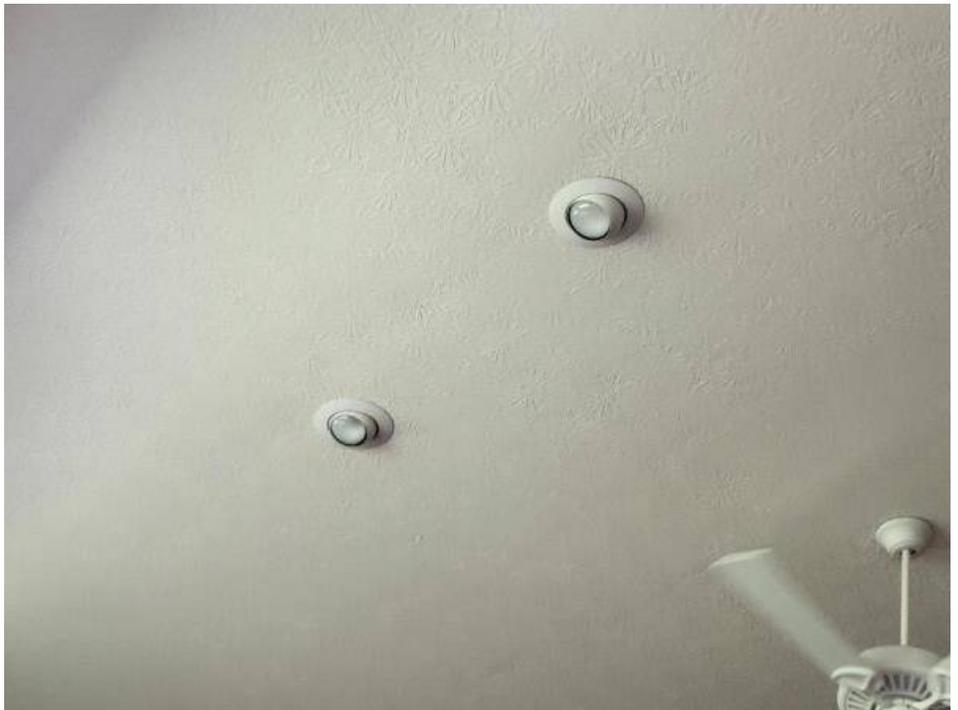
The homes ceilings have typical nail pops from settlement or movement. The homes drywalled

ceilings have typical stress cracks due to settlement or movement.

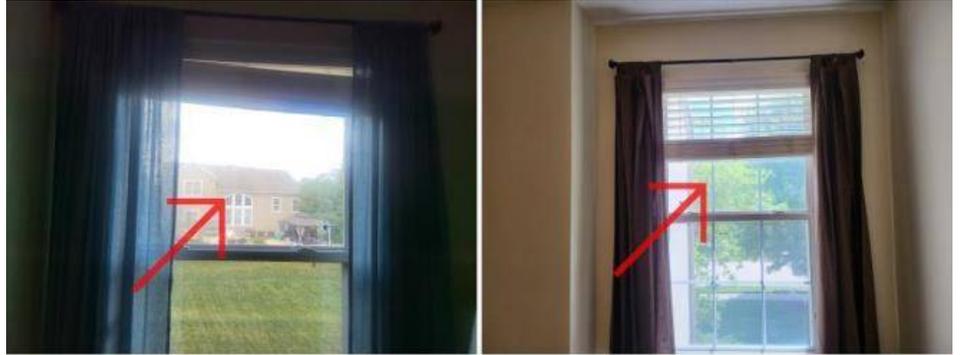
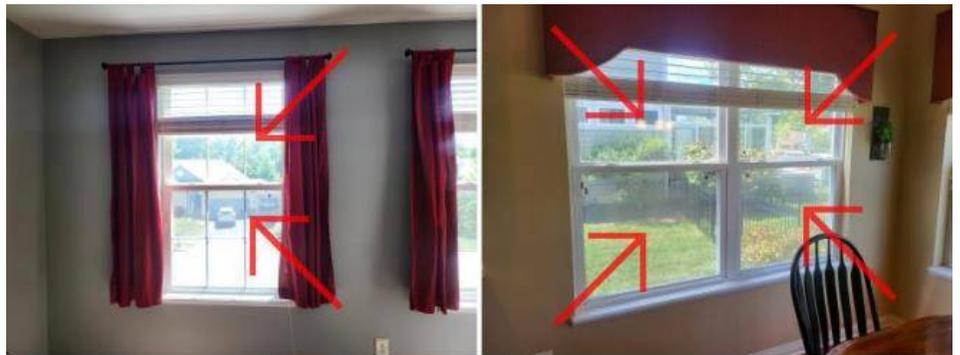
The dinette side, master bedroom left, right guest bedroom and left windows have visible broken seals (moisture between panes of glass) and will need further evaluation. Recommend contacting a qualified glass specialist to determine the exact "number of windows" that will need repair or replacement.

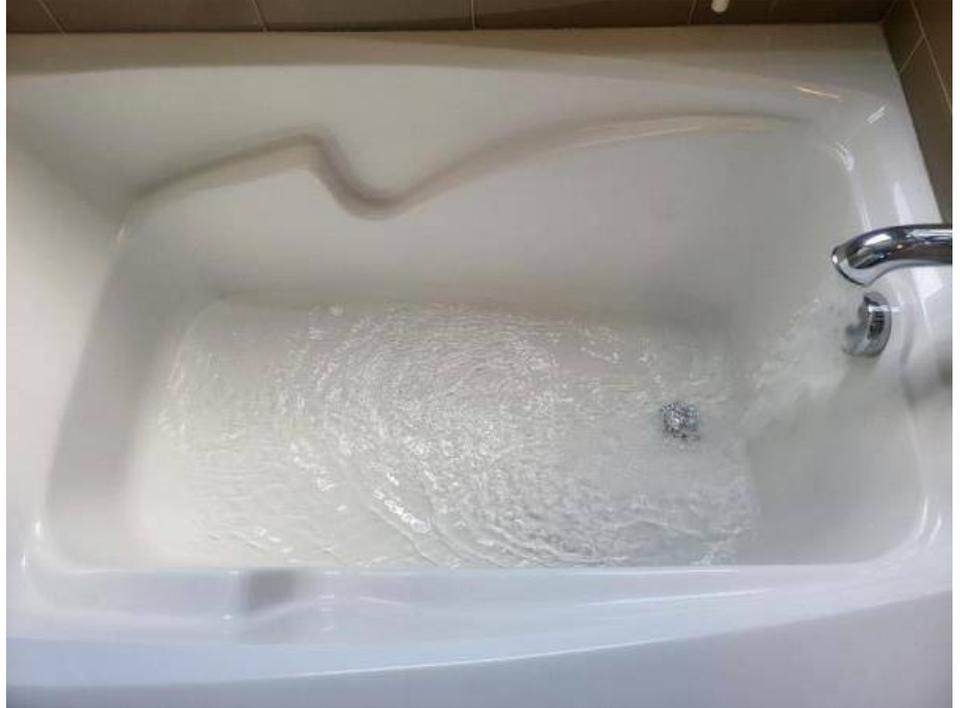
The hall bathroom sink & tub and master bathroom

tub tested "slow-drain" the day of inspection and will need the drain-stopper adjusted and/or wasteline cleared as required for adequate drainage.

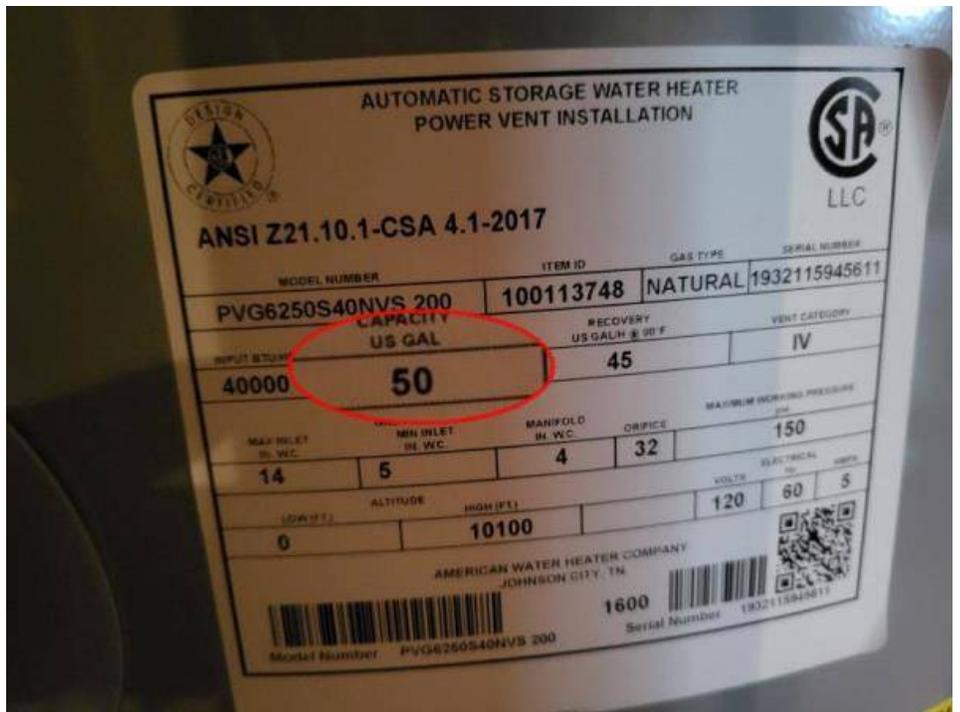
The homes hot water tank has a "thermal-blanket" and unit could not be fully inspected or judged and should be removed for safety. 50 Gallons.

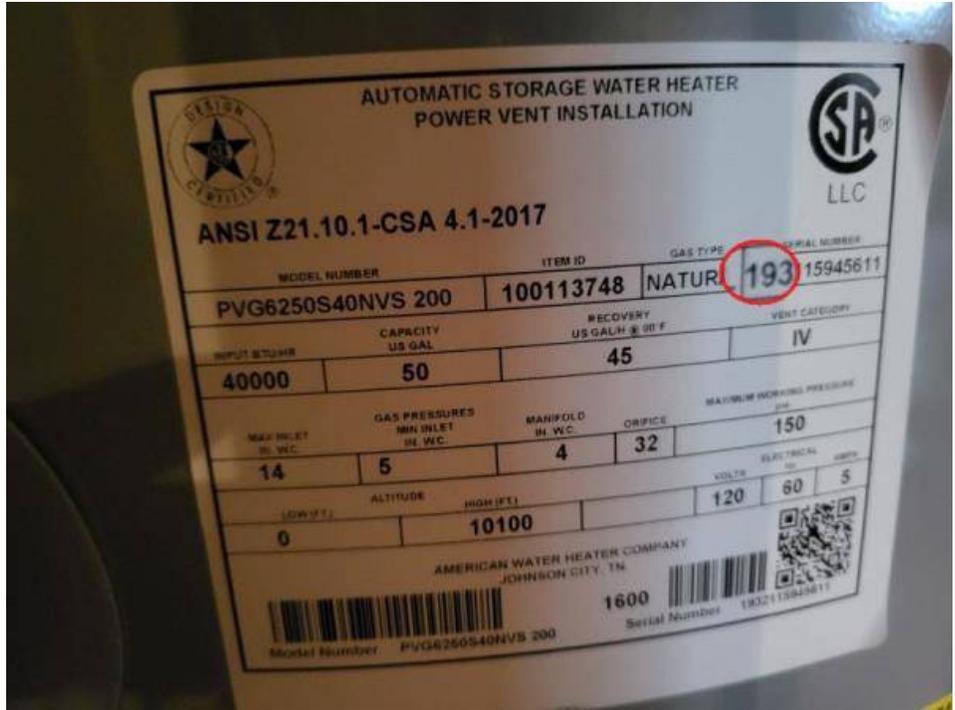
The homes hot water tank has a "thermal-blanket" and unit could not be fully inspected or judged and should be removed for safety.

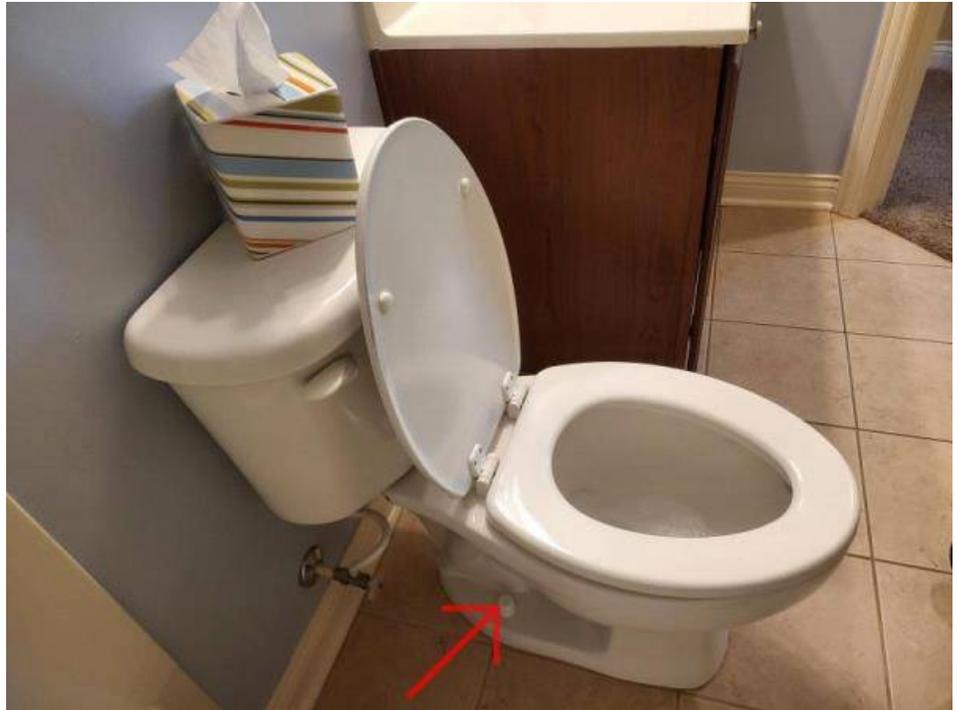
The upstairs hall bathroom commode is, The visible area(s) of the bathrooms were inspected and appeared functioning as intended except for comments-made and normal wear and tear. See Plumbing Fixtures for additional information. extremely loose and will need professionally secured as required to prevent future damage.

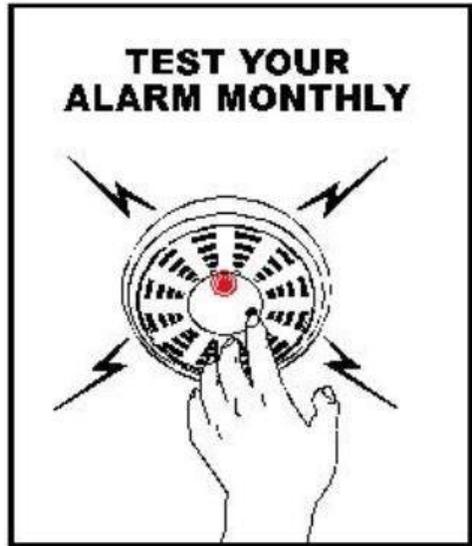
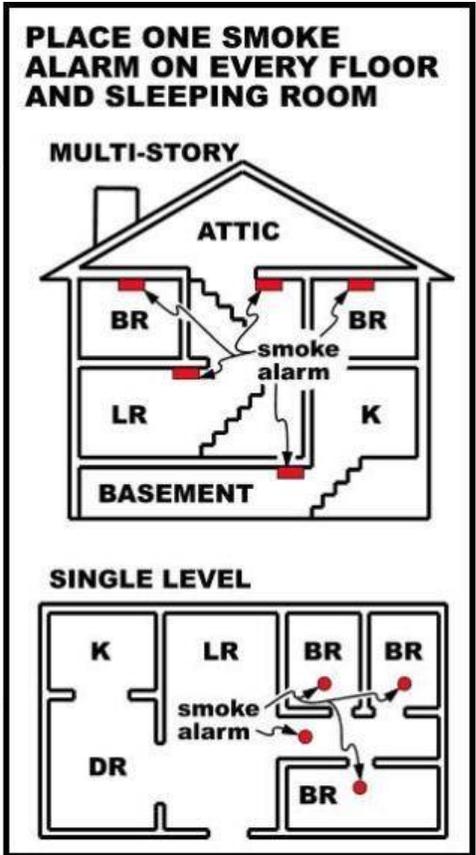
Recommend installing or updating old outdated Smoke and/or Carbon Monoxide Detectors in home for life-safety.
