Report: [REDACTED] -Inspection Address: [REDACTED]

Confidential Inspection Report

NATIONAL HOME INSPECTION SERVICE INC.

SUMMARY OF AREAS REQUIRING FURTHER EVALUATION

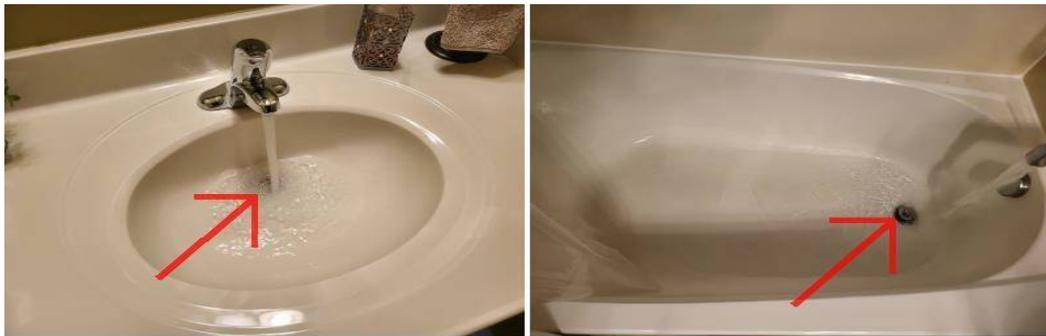
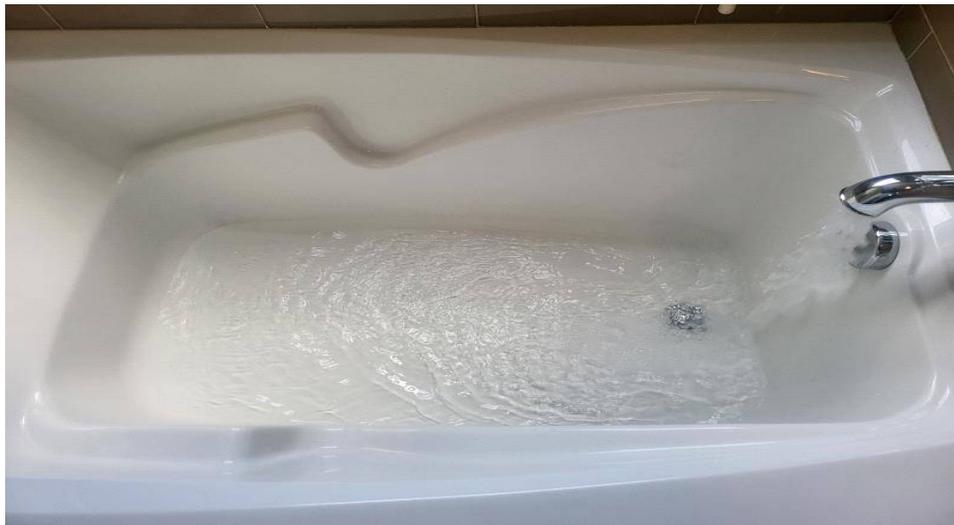
WASTE FLOW:

The hall bathroom sink & tub and master bathroom tub tested "slow-drain" the day of inspection and will need the drain-stopper adjusted and/or wasteline cleared as required for adequate drainage.

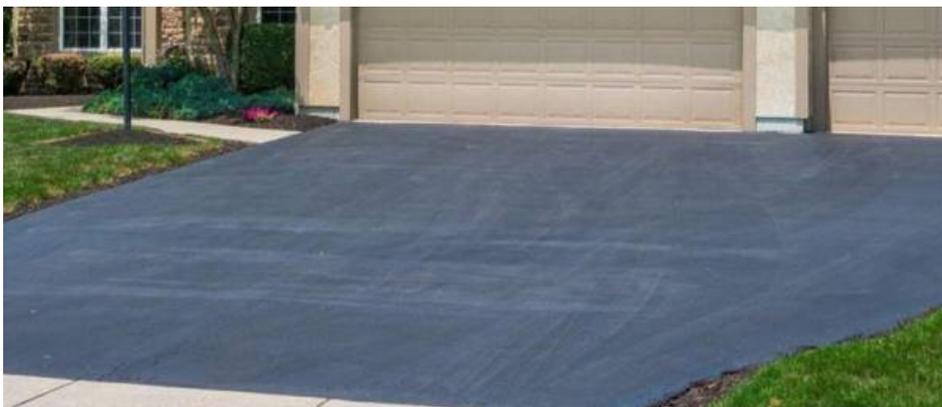
DRIVEWAY:

Asphalt.

The homes driveway has typical stress cracks due to age and/or ground settlement or movement.

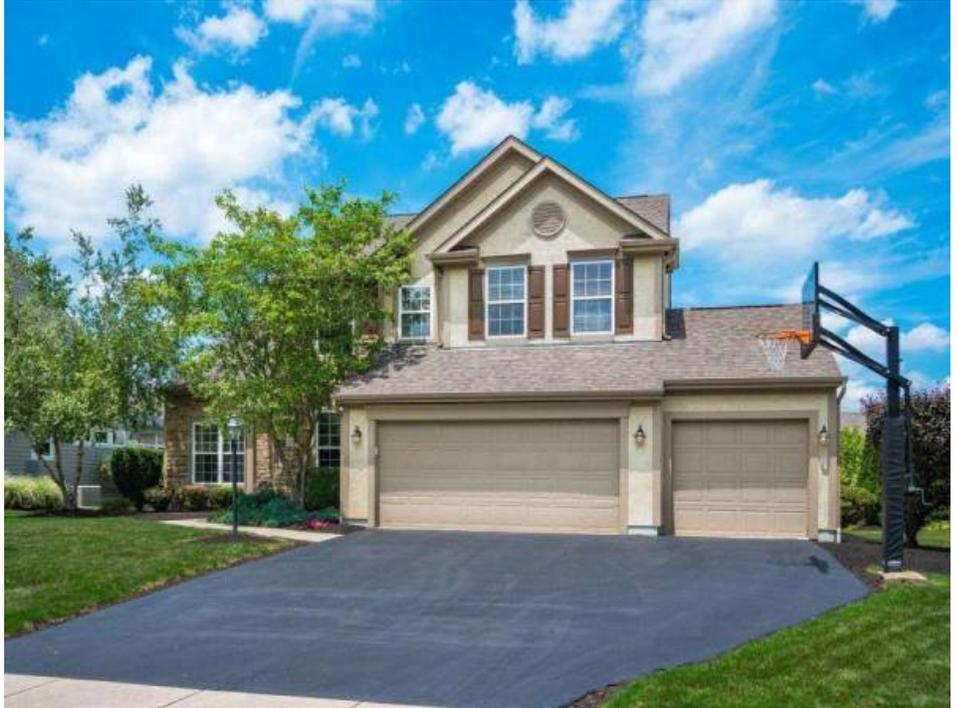
LANDSCAPING:

The visible areas of the landscaping beds were cut back from structure. Recommend maintaining trees and vegetation to prevent damage to roof structure and insect activity.

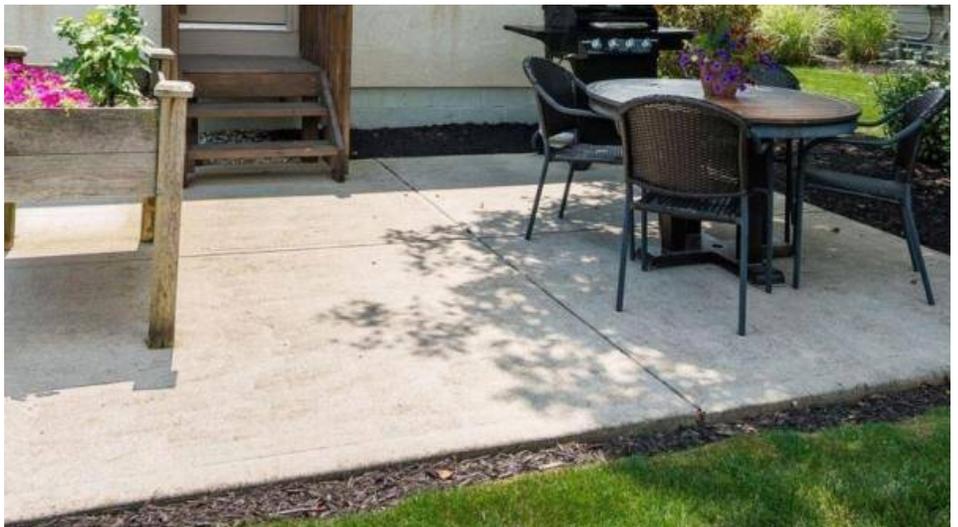
PATIO/TERRACE:

Concrete.

The homes patio has typical stress cracks due to ground settlement or movement.

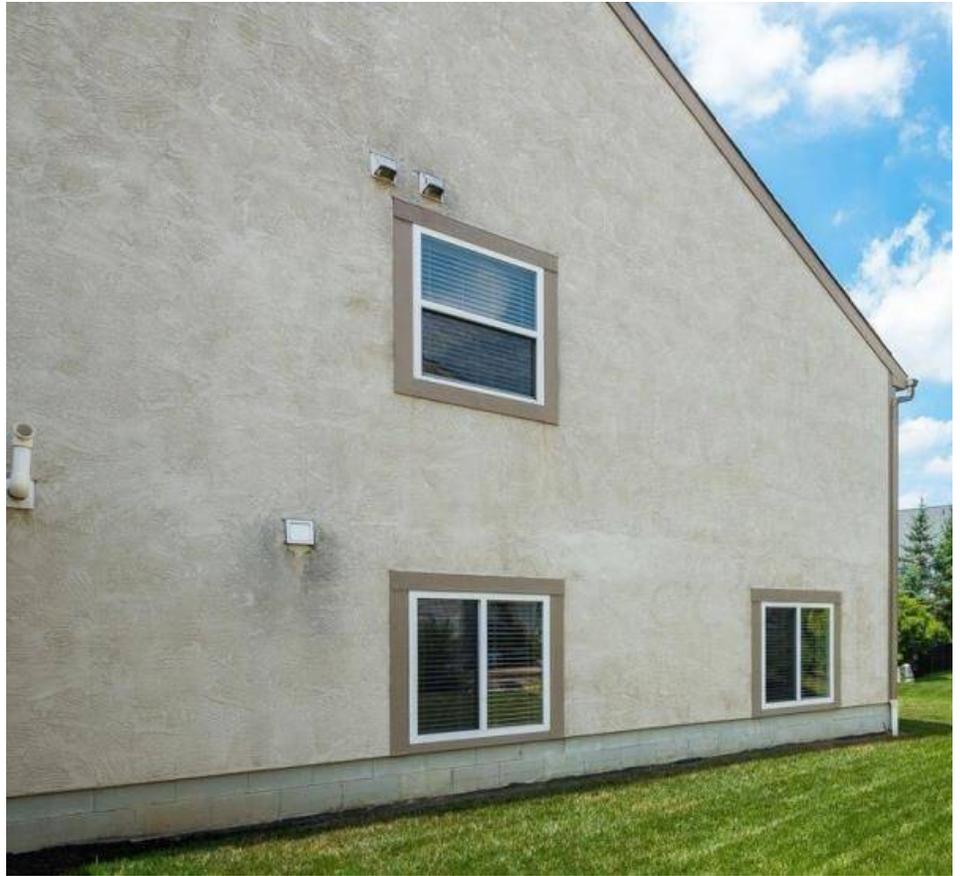
TRIM MATERIAL:

Composite Board.

The composite trim under the gutter on the rear of the home had moisture damage that will need professionally repaired. Recommend contacting a qualified exterior trim specialist for further

evaluation and recommendations and actual cost of repair or replacement.

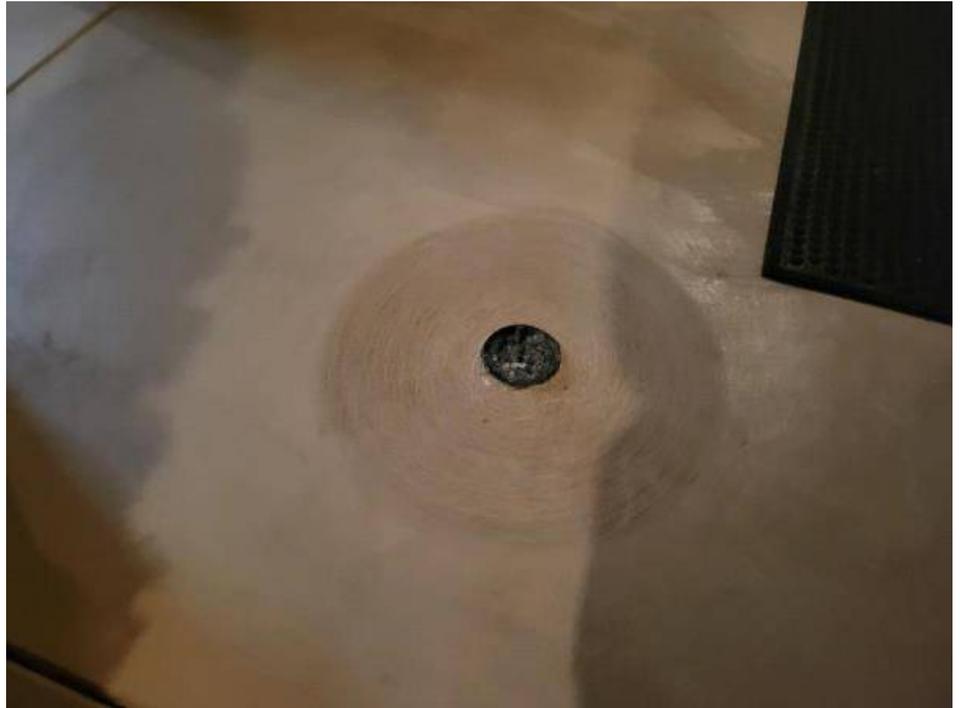
FLOOR:

Concrete Slab. Typical Concrete Stress Cracks.

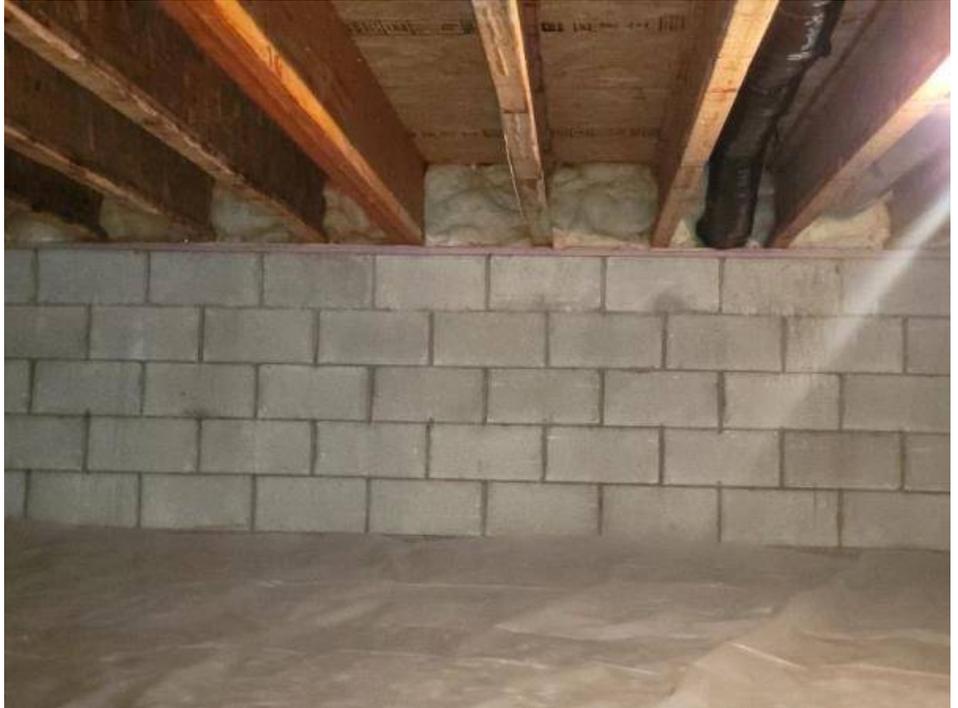
WALLS:

The homes crawl spaces walls, rim joists and sill plates were insulated and covered-up and not inspected or judged.

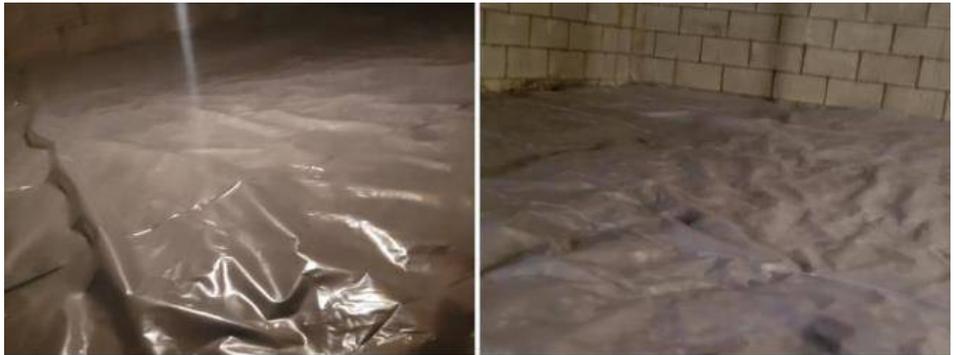
FLOOR:

The homes crawl space floor was graveled. The homes crawl space floor had a vapor barrier.

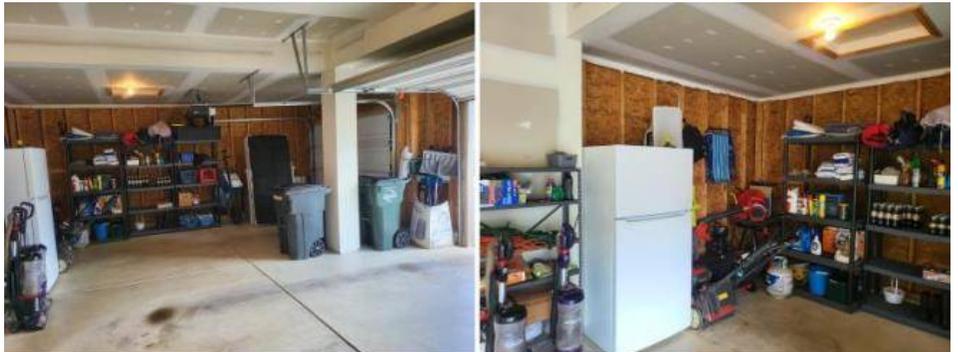
WALLS:

Partially Enclosed. Bench and Shelving. Extensive Storage. Tools and Equipment. Cluttered Conditions.

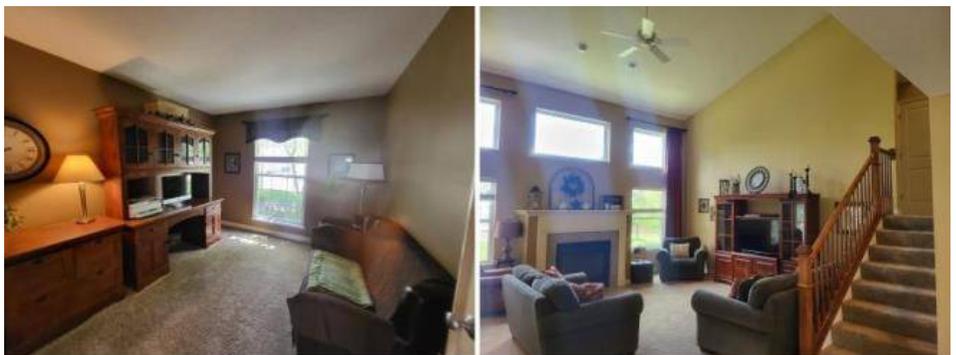
WALLS:

Drywall.

The homes drywalled walls have typical stress cracks from settlement or movement.

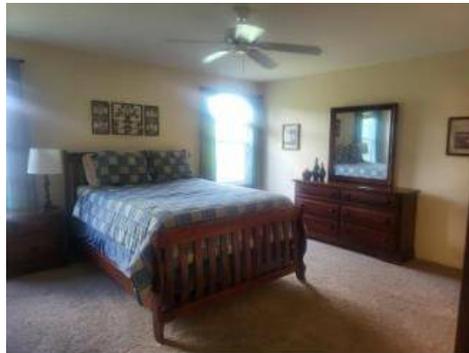
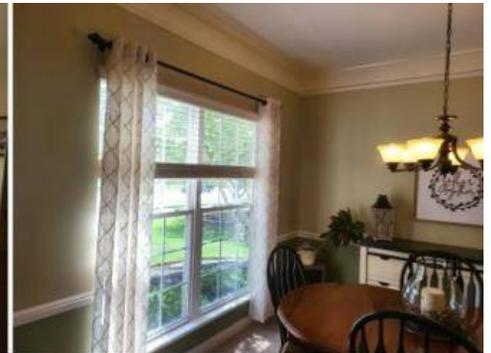
WINDOWS:
TYPE:

The dinette side, master bedroom left, right guest bedroom and left windows have visible broken seals (moisture between panes of glass) and will need further evaluation. Recommend contacting a qualified glass specialist to determine the exact "number of windows" that will need repair or replacement.

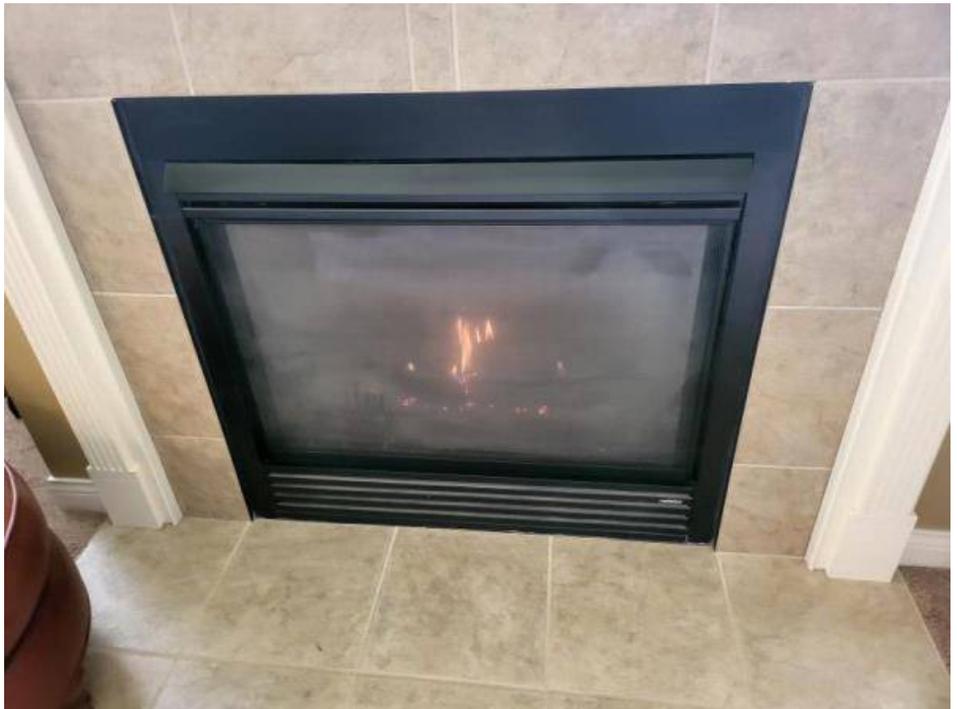
FIREPLACES:

The fireplace inspection revealed a "enclosed gas log system" that was vented out the side of the home. The home inspector is not qualified to judge or give an opinion concerning the operation and/or

The visible areas of the homes fireplace were inspected; however, the home inspector is not qualified to judge or give an opinion concerning the internal condition of the chimney's components, including but not limited to, wood burning stoves, flue liners, smoke chambers, fireboxes, dampers, vented or ventless gas log systems and other related equipment, and is not part of this inspection or report. Recommend having a qualified chimney specialist clean and inspect using a video camera to determine the internal condition of the chimneys metal vent or flue pipe prior to use for fire-safety.

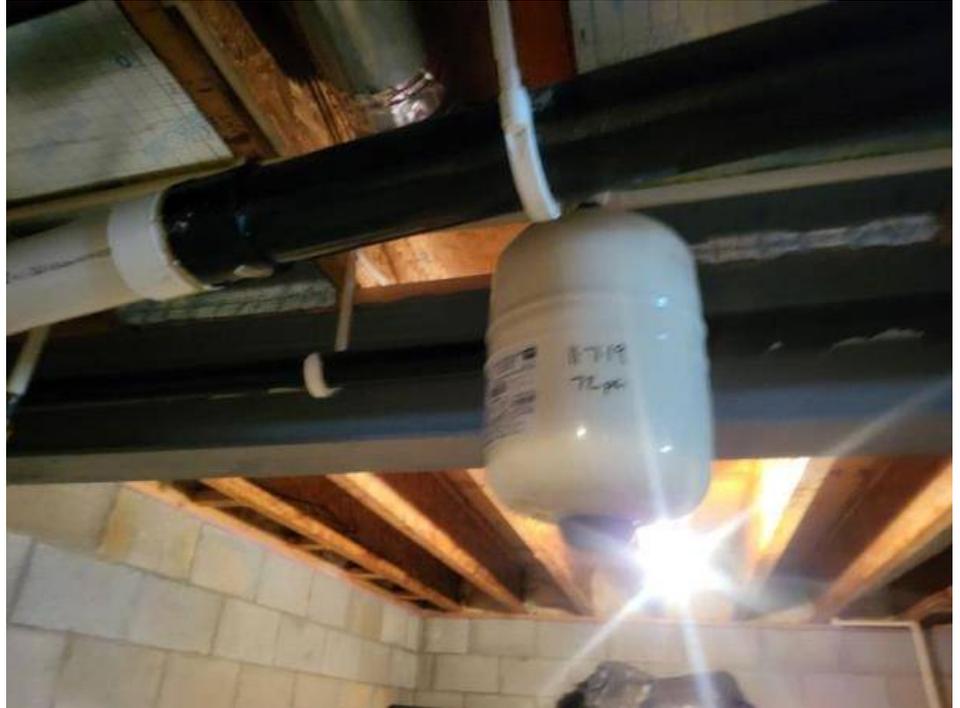
H2O EQUIPMENT:

The home has water expansion tank that was not tested or judged and is not part of this inspection. Recommend contacting current owner for operating manuals/information and name of contractor servicing the equipment.

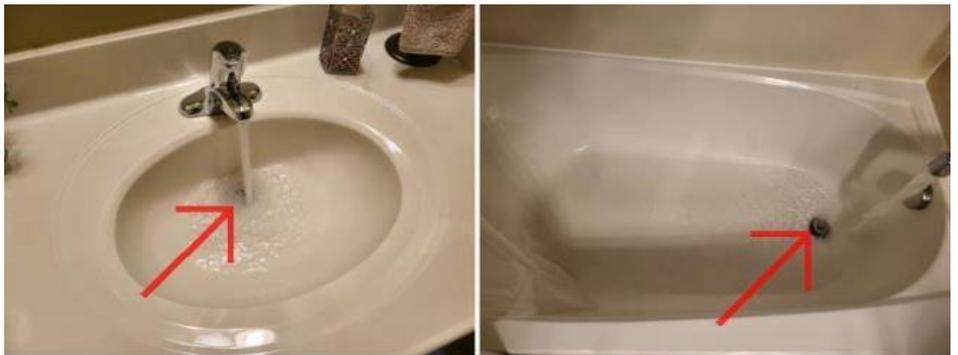
WASTE FLOW:

The hall bathroom sink & tub and master bathroom

tub tested "slow-drain" the day of inspection and will need the drain-stopper adjusted and/or wasteline cleared as required for adequate drainage.

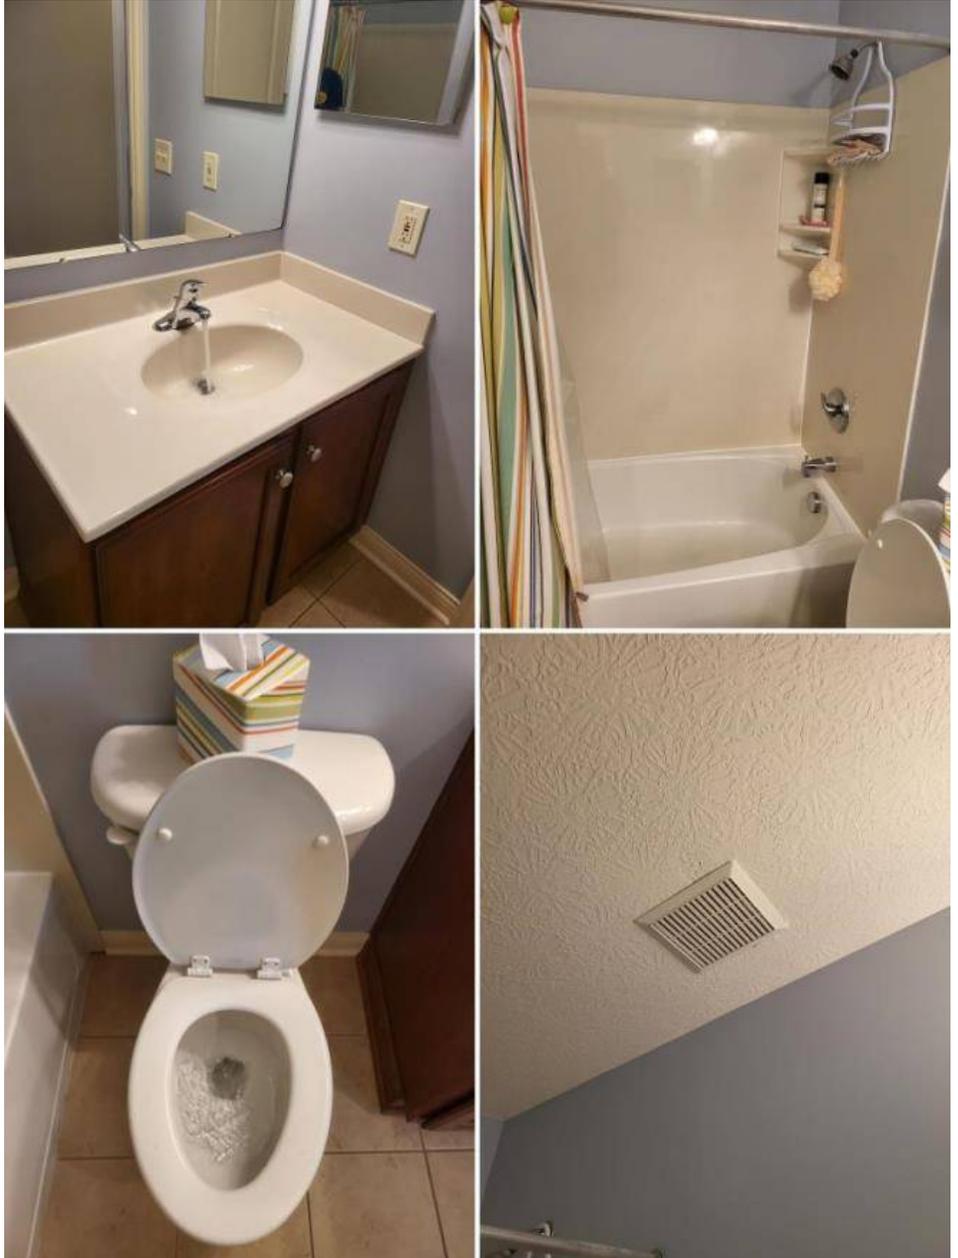
HALL:

Commode. Sink. Vanity. Fan. Floors: Ceramic. Built In Tub. Fiberglass.

The upstairs hall bathroom commode is, The visible area(s) of the bathrooms were inspected and appeared functioning as intended except for comments-made and normal wear and tear. See Plumbing Fixtures for additional information. extremely loose and will need professionally secured as required to prevent future damage.

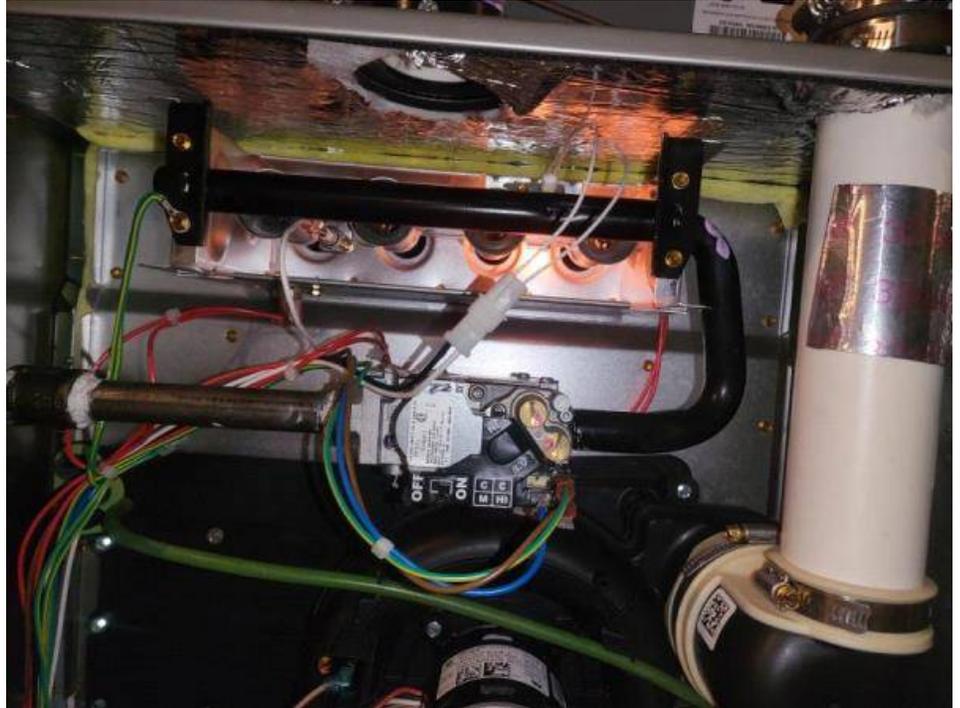
SYSTEM TYPE:

The home has a High Efficiency (90%+) gas fired forced air heating system with ductwork.

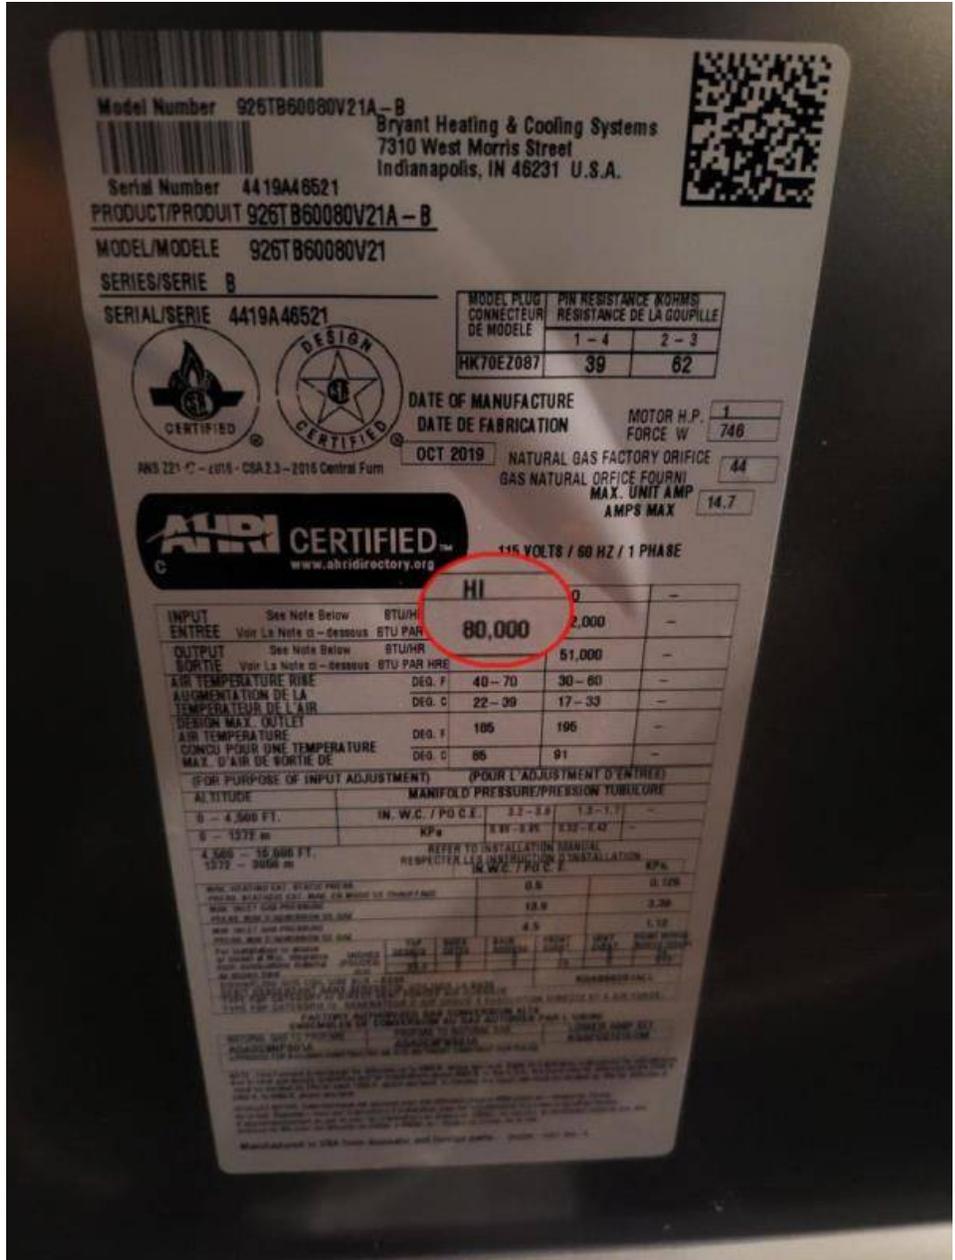
NO. 1 CAPACITY:

80 K BTU.

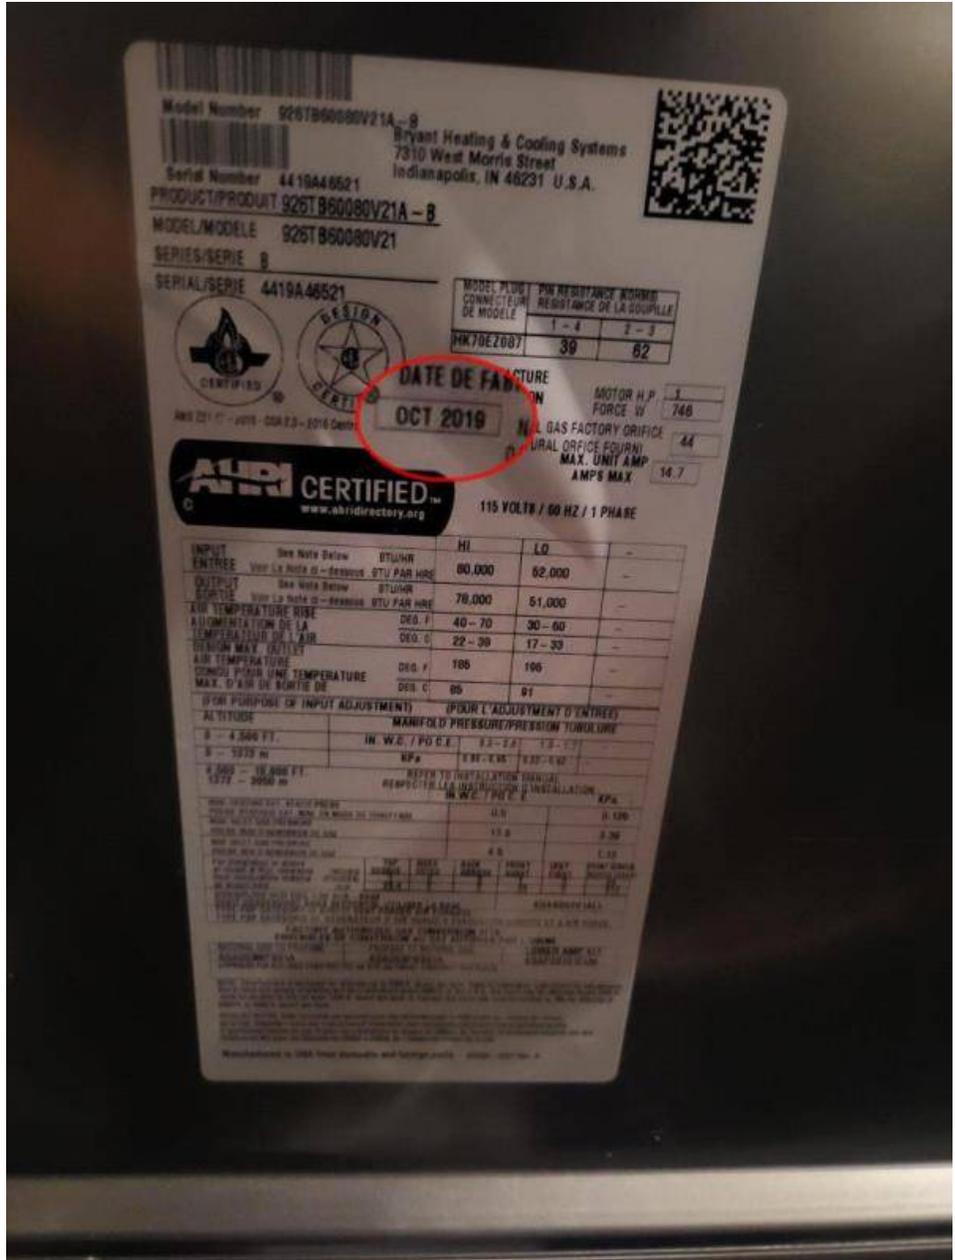
NO. 1 AGE:

2019.

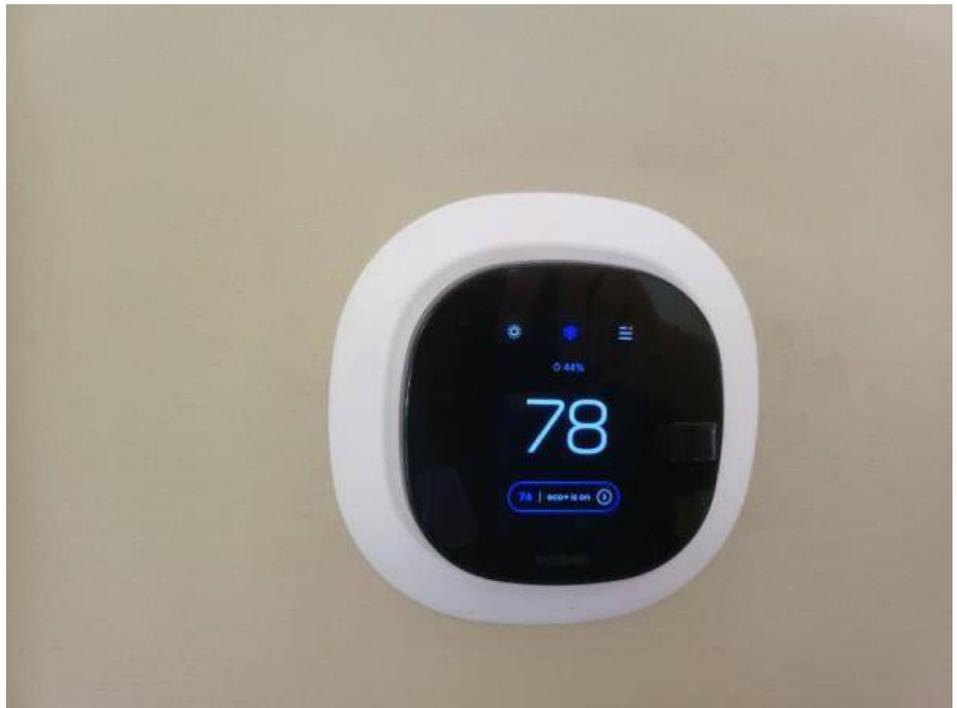
THERMOSTAT:

The homes primary heating system responded to the thermostat when tested but was not checked for "adequacy or accuracy of function".

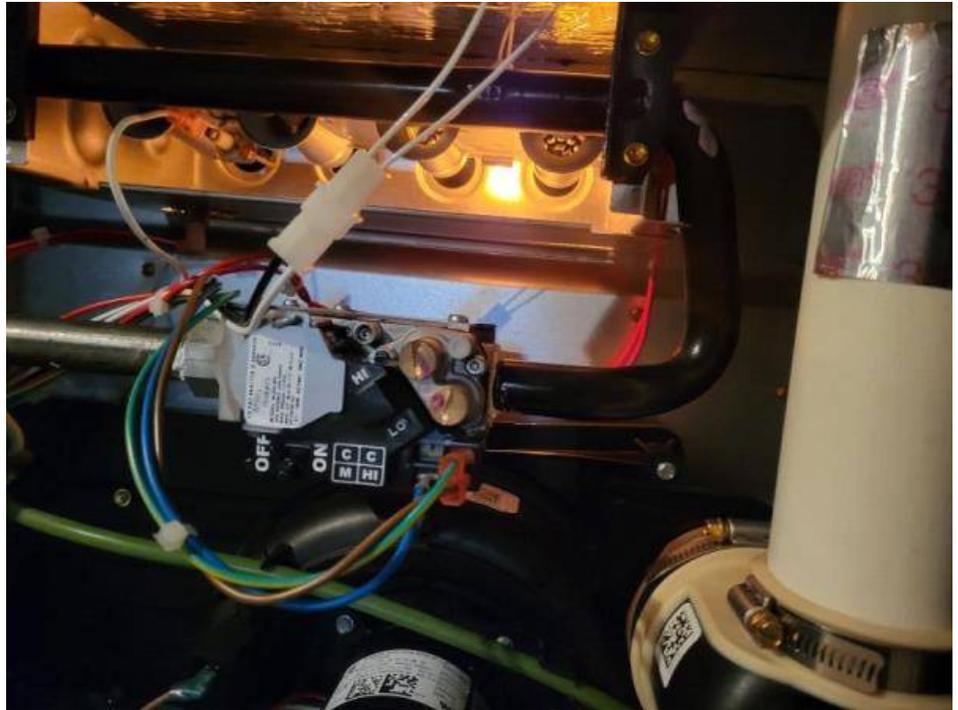
EXCHANGER:

The furnaces heat exchanger area was not fully accessible without dismantling the unit. The home inspector is not licensed or qualified to remove components during a visual inspection. Recommend having a licensed and qualified HVAC contractor clean and service the system prior to use for safety and efficiency and obtain a Service Contract with a licensed and qualified HVAC contractor to extend life expectancy.

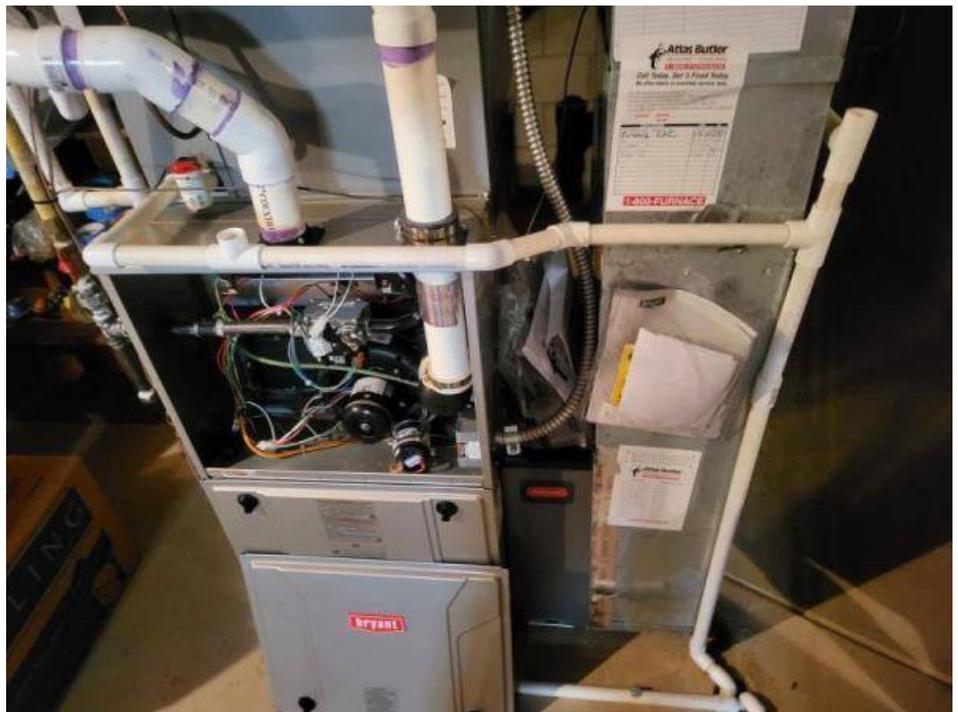
HEAT SOURCE:

All living areas (not all rooms) of the home appear to have a heat source. The home inspector cannot judge the adequacy of the HVAC system due to the short time period of the inspection and outside weather conditions. After living in the home it may be necessary to have the HVAC system balanced-out

or supplemental systems installed based on your specific heating and cooling needs. NOTE: Recommend contacting a qualified specialist and balance-out the HVAC system for efficiency and economic savings.

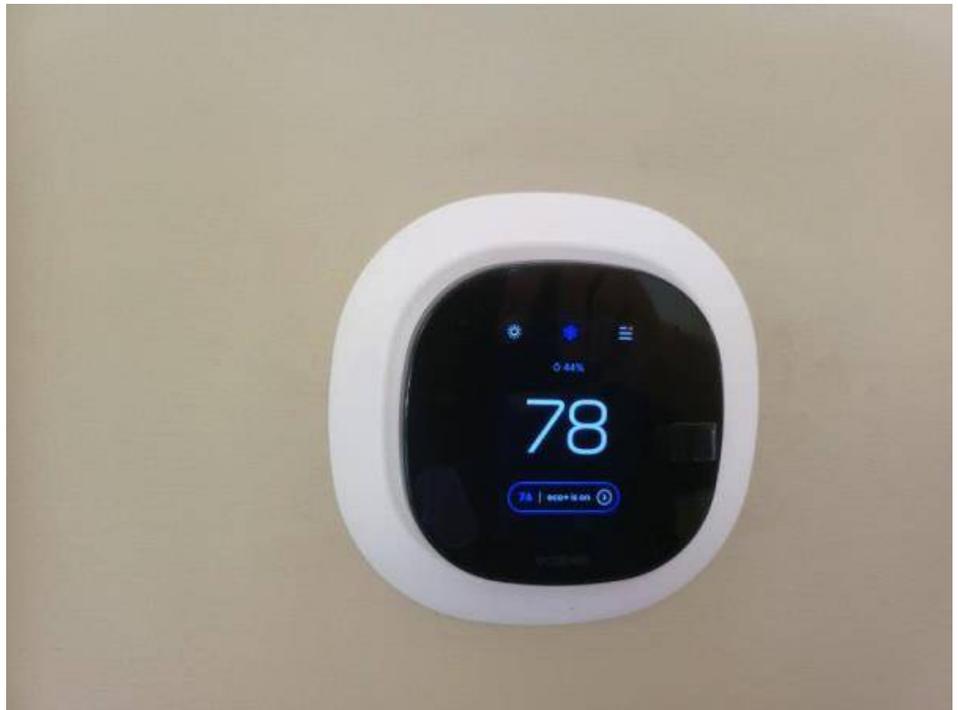
THERMOSTAT:

The homes cooling system responded to normal controls (thermostat) and had change in temperature within normal the normal (15-21 degrees) operating range; however, the system was not checked for "adequacy or accuracy of function". Recommend having a licensed and qualified HVAC contractor clean and service the system prior to use for safety and efficiency. Also recommend maintaining a service contract with a licensed and qualified HVAC contractor.

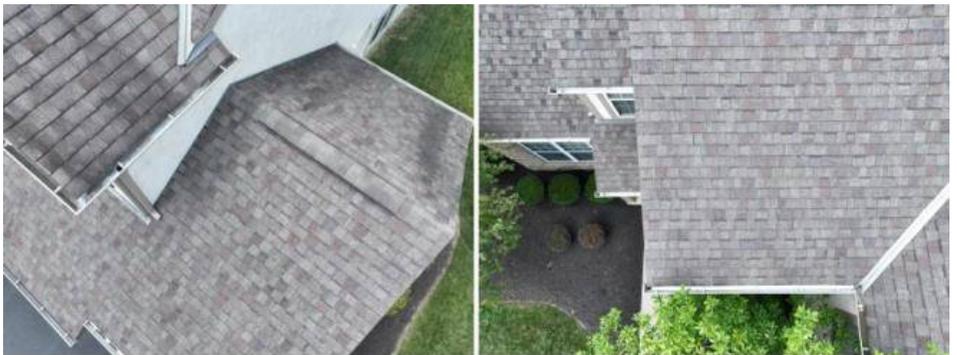
APPROX AGE:

5-10 Years.

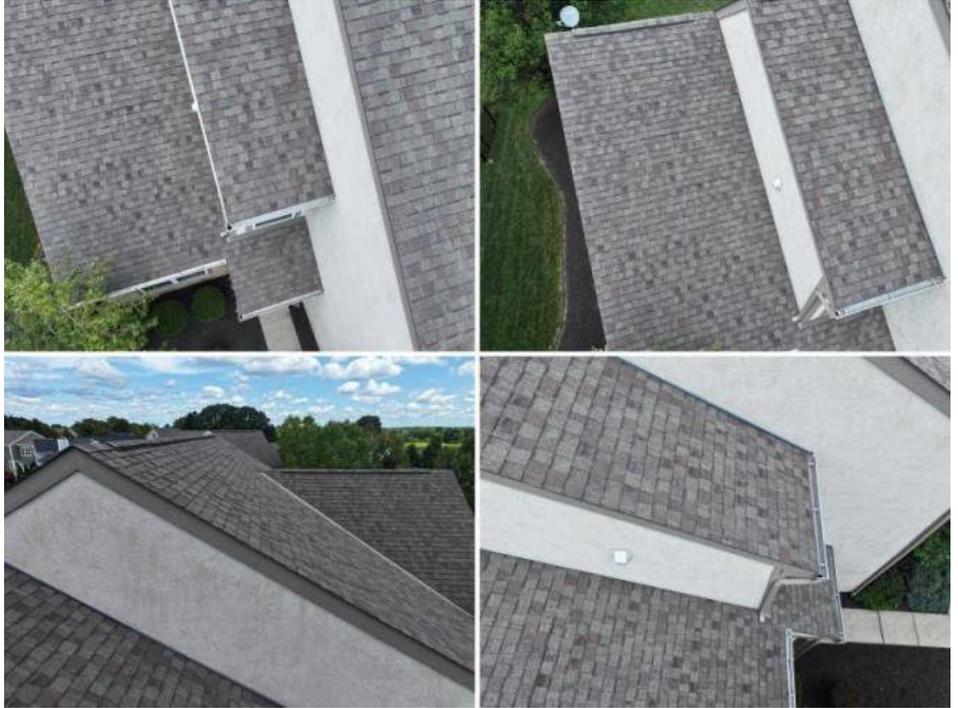
LEAKAGE:

The roof system had no visible roof or flashing leaks the day of inspection.

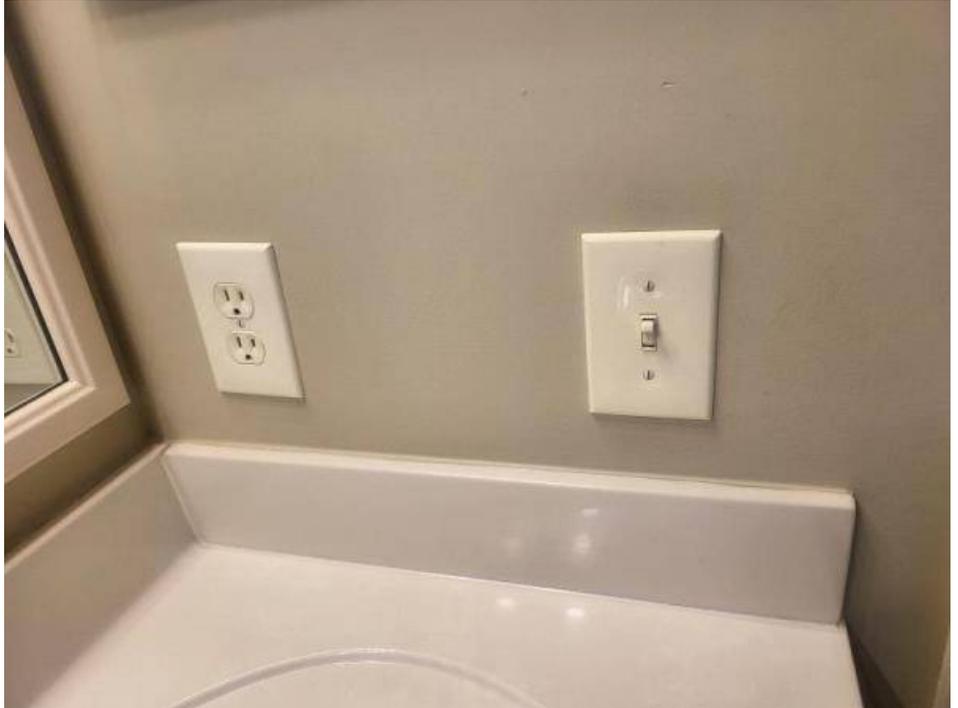
RANDOM TESTING:

A representative sampling of switches and outlets were tested and appear serviceable.

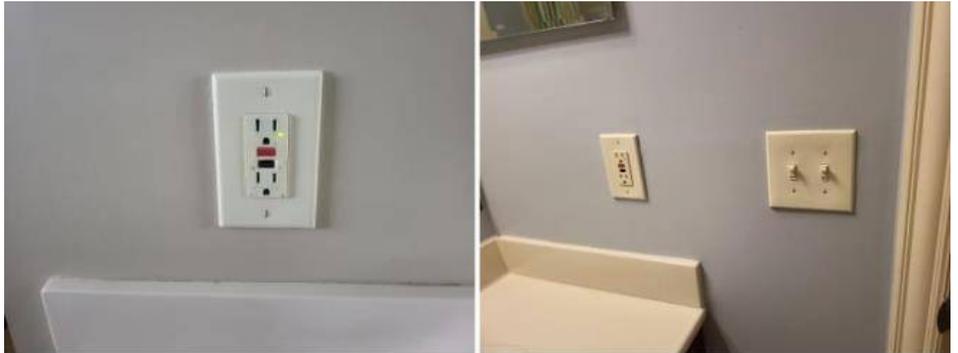
GFCI PROTECTION:

A representative sampling of (GFCI) Ground Fault Circuit Protection outlets were tested and appear serviceable.
